NASA TM X-64597

HYPERVELOCITY IMPACT TESTS ON A  
PROPOSED LUNAR TUG FUEL TANK CONFIGURATION

By David William Jex  
Space Sciences Laboratory

April 16, 1971

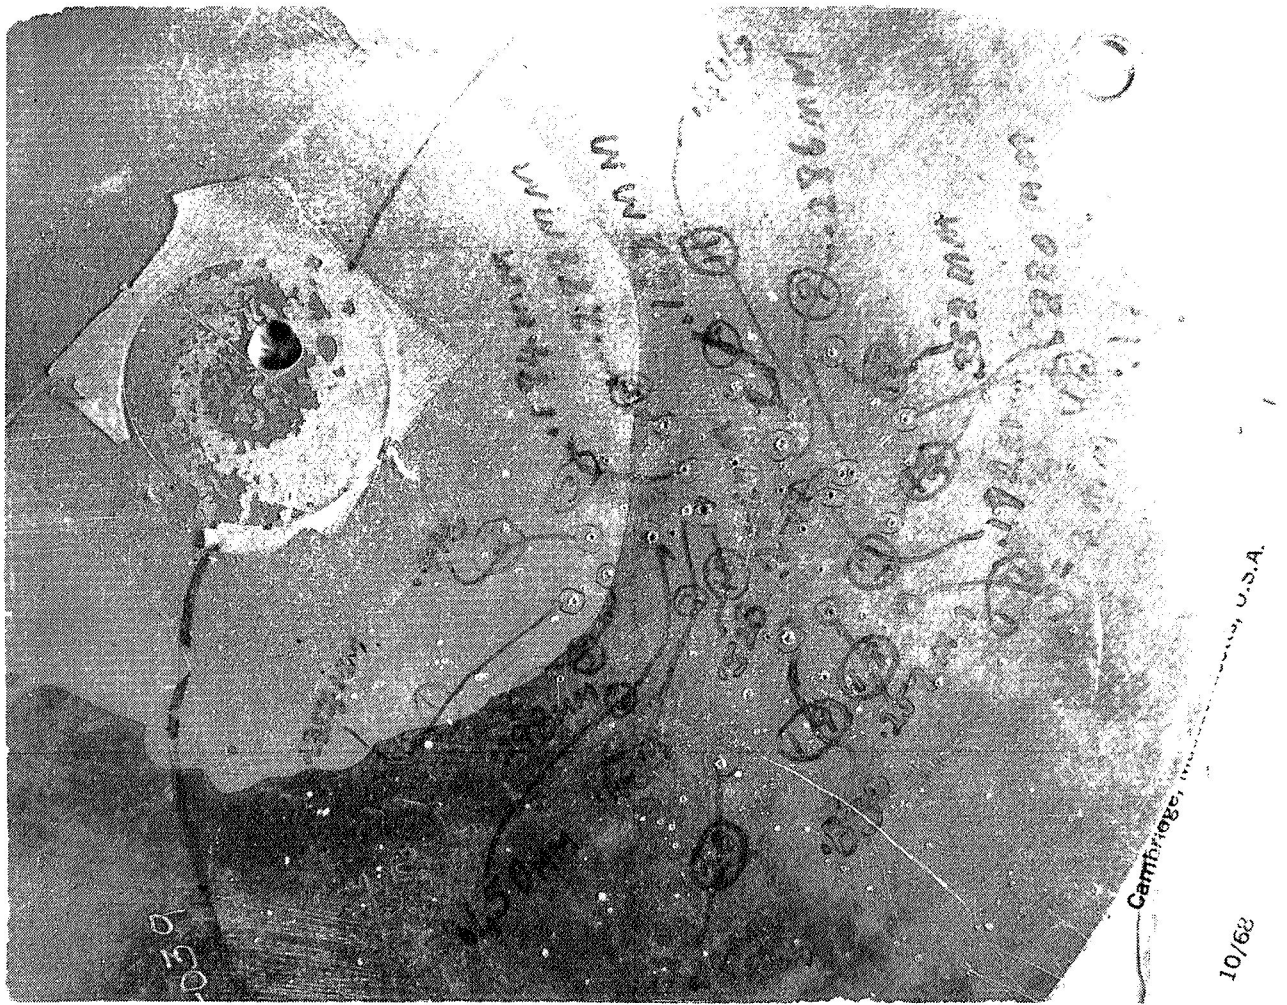
Figure 4. Damage incurred on backup sheet for bumper only,  
no thermal blanket.

The damage to the front configuration on the impact of the bumper only, with no thermal blanket, is shown in Figure 3. The damage to the backup sheet is shown in Figure 4. There was no observable damage to the nylon stringer.

The number of craters formed by debris particles resulting from this impact are listed in Table 1 as a function of the distance from the intersection of the backup sheet and primary line of flight. The distinction

between significant debris craters and all craters was based on visual observation of the damage sustained by the backup. A deep, hemispherical crater was considered a significant crater, while a shallow or uneven crater would not be considered significant since the debris particle forming such a crater would not be a dangerous hypervelocity debris particle.

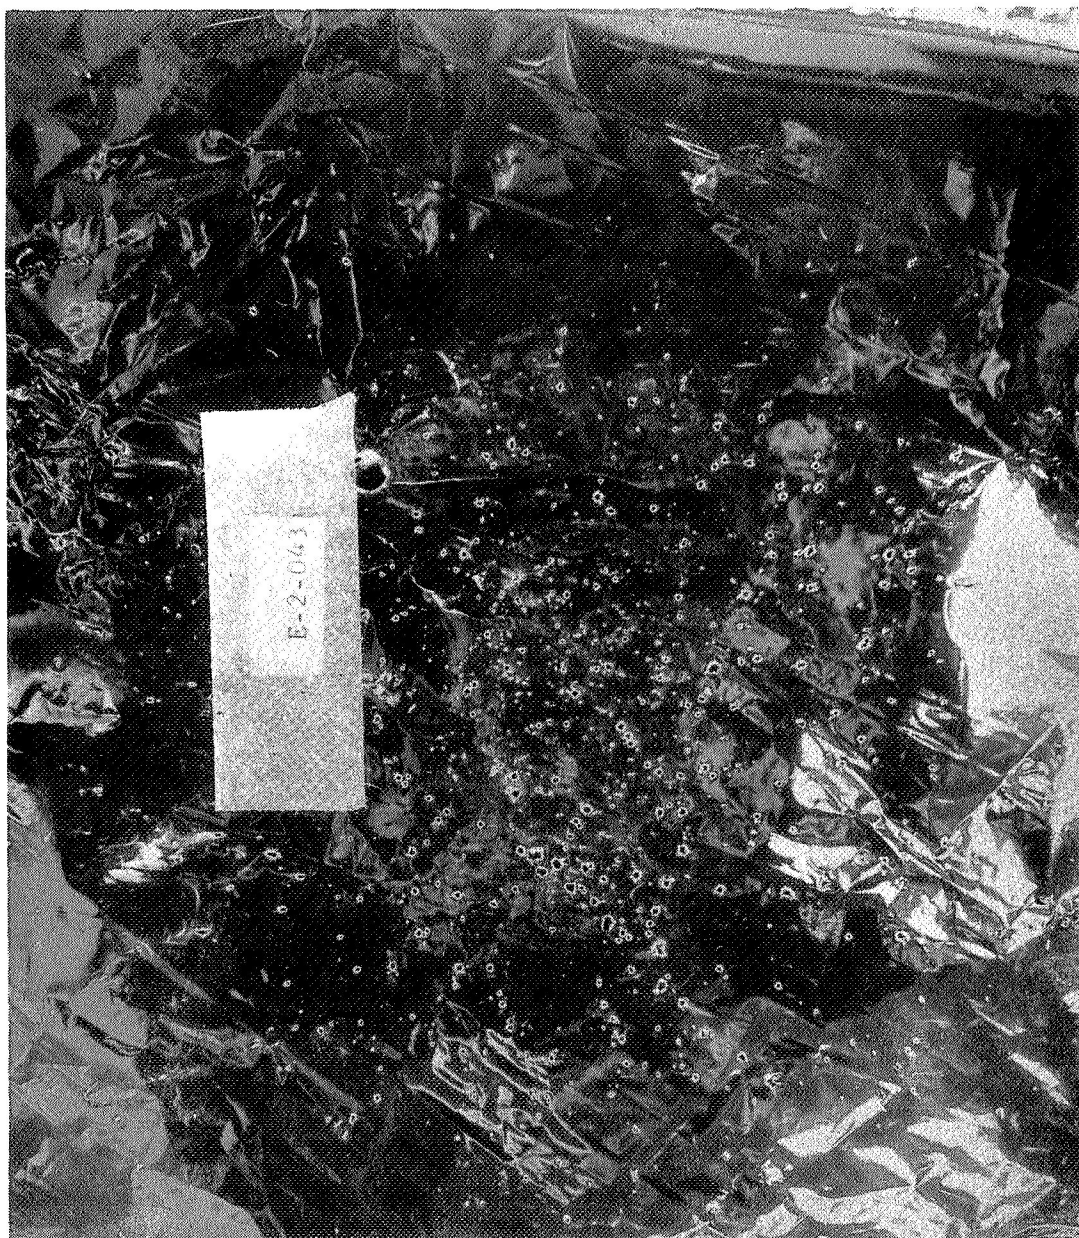
Figure 6. Damage to first aluminized mylar sheet in thermal blanket.

The thermal blanket was resting against the backup sheet. This placement allows the debris particles to spread out a maximum distance from one another for maximum interaction of the individual particle with each sheet of blanket. The damage sustained by the first sheet of the blanket is shown in Figure 6. The 15th sheet of the blanket is shown in Figure 7, and the quilted aluminum sheet at the rear of the blanket is shown in Figure 8. The damage sustained by the backup sheet is shown in Figure 9.

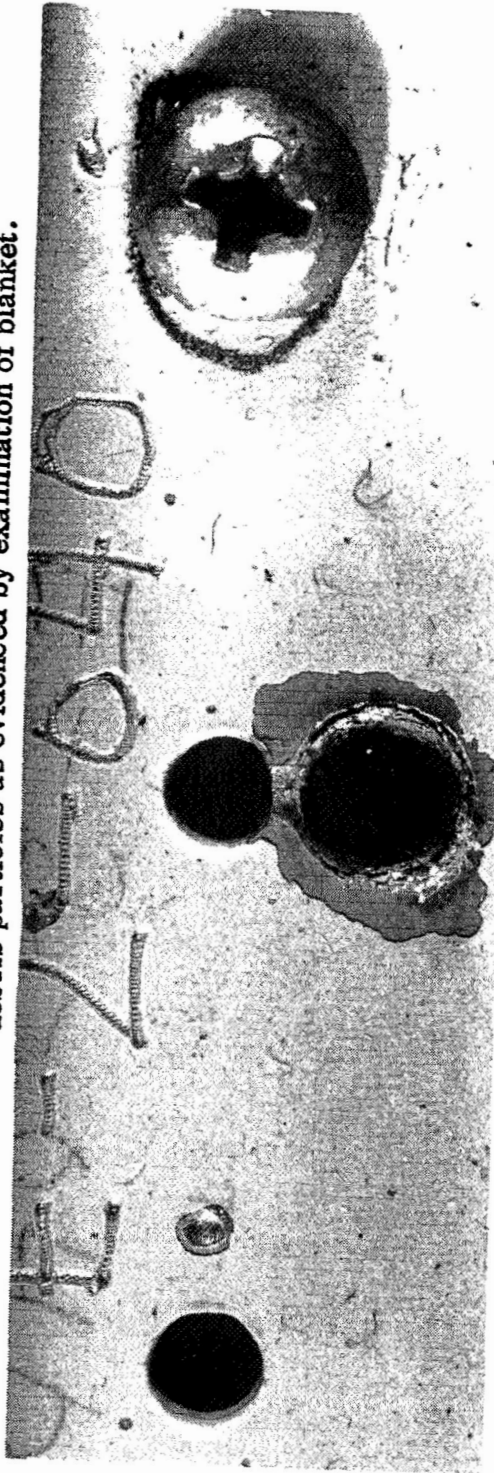
Figure 11. Damage of projectile impact on brace and bumper, without thermal blanket.

The impact of the projectile on the front configuration and the damage to the backup sheet are shown in Figures 11 and 12.

It is obvious that there was no damage to the backup or stringer that warrants investigation.

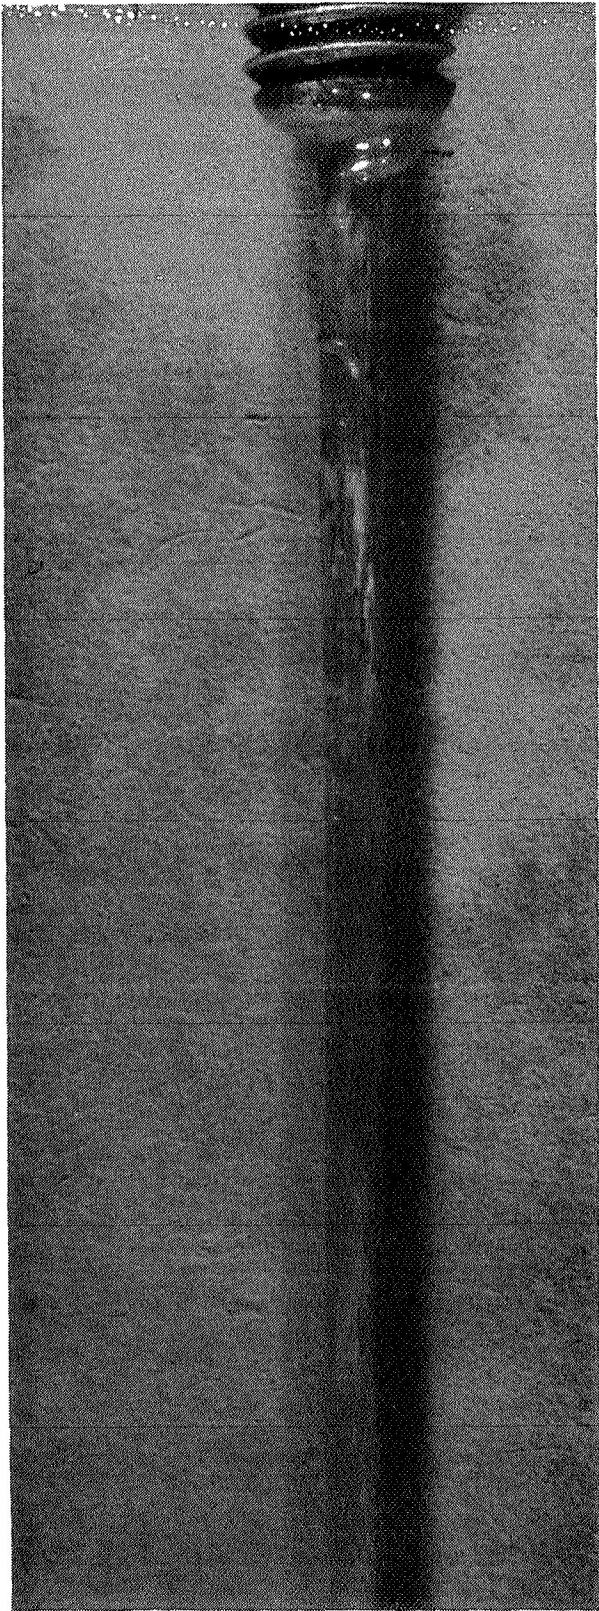
Figure 17. Magnified view of stringer on the impact of brace only.

A magnified view of the stringer is shown in Figure 17. It can be seen that although a small amount of damage was sustained, it did not cause the stringer to sever under the tension of 22.65 kg.
